Danish EV Committee
Per Jørgensen Møller

23-09-2003

Investigation of breakdown of the SAFT STM5-100 battery

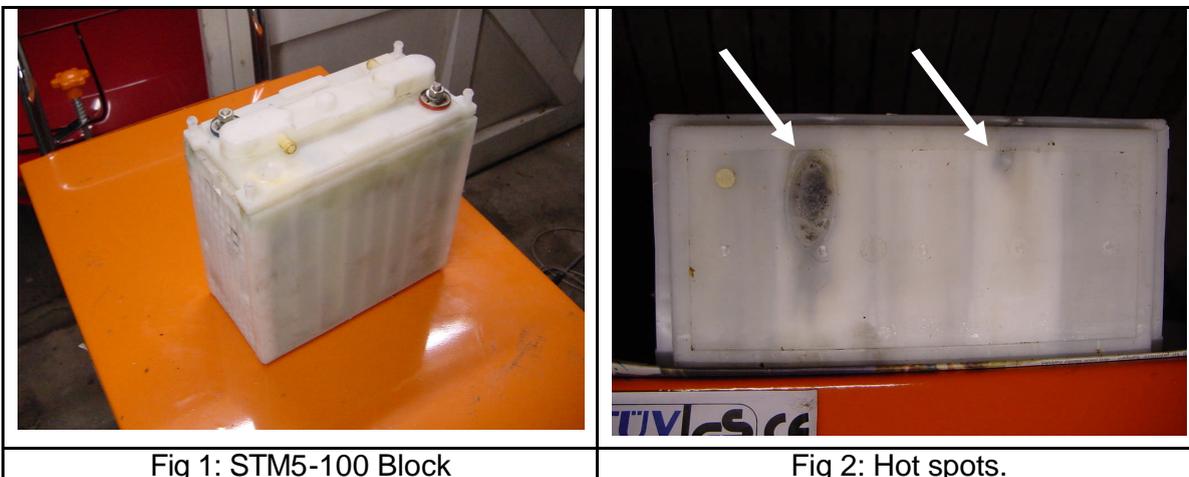
Fig 1: STM5-100 Block

Fig 2: Hot spots.

In this case it can be seen on the bottom plate of the block on Fig2 that two cells - #2 and #4 - in the five cell block have developed a lot of heat, which nearly has melted holes in the bottom plate. This amount of heat can only be developed by a rather solid short circuit between the anode and the cathode plates.

The most likely reason for such a condition is a breakdown of the separator in the battery. To further confirm this hypothesis one of the defective blocks was disassembled. The endplate was cut loose around the edge and the battery plates were investigated further.

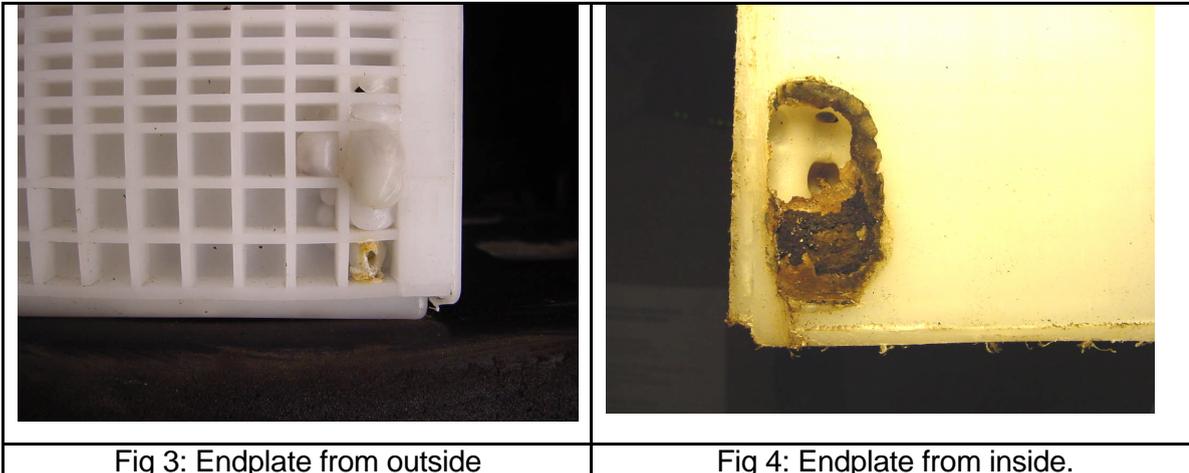
The endplate of the block can be seen here under Fig. 3 from outside and Fig.4 from inside.

In this case it can be clearly seen that the heat development has been so strong that the strengthened endplate was melted through and hot electrolyte has leaked out in the battery case. If this only happens for a single cell it is possible to continue using the battery, but the problem will be revealed at the next water refill as the water will leak from the hole and remaining cells on the refill string will not be filled.

This can then result in that some cells will run out of electrolyte if usage of the battery is continued. Looking at the active cell plates following can be seen:

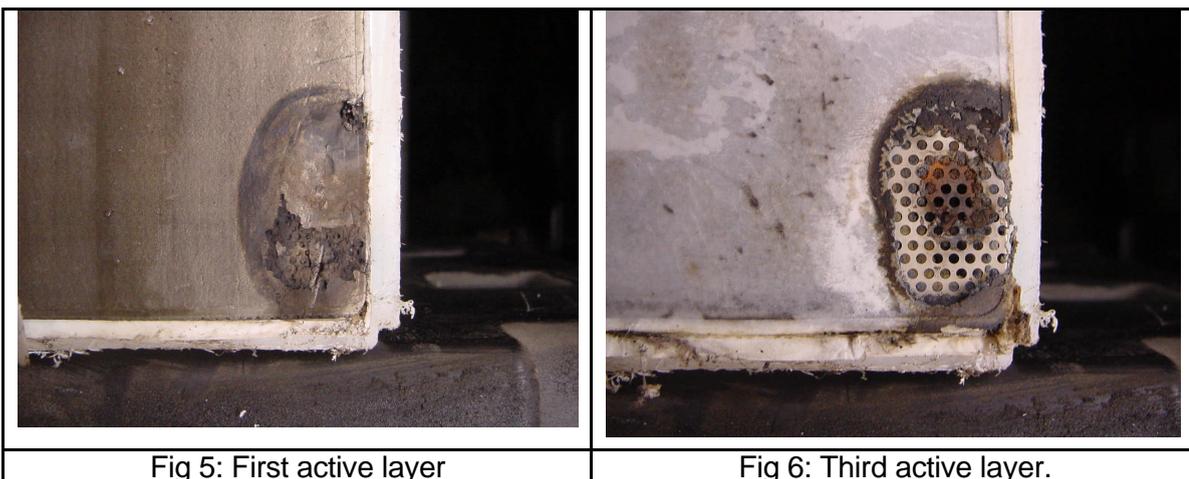
It is clear from the above pictures that the center of heat development was concentrated in the third layer as only the steel mesh, which has carried the active material is still remaining.

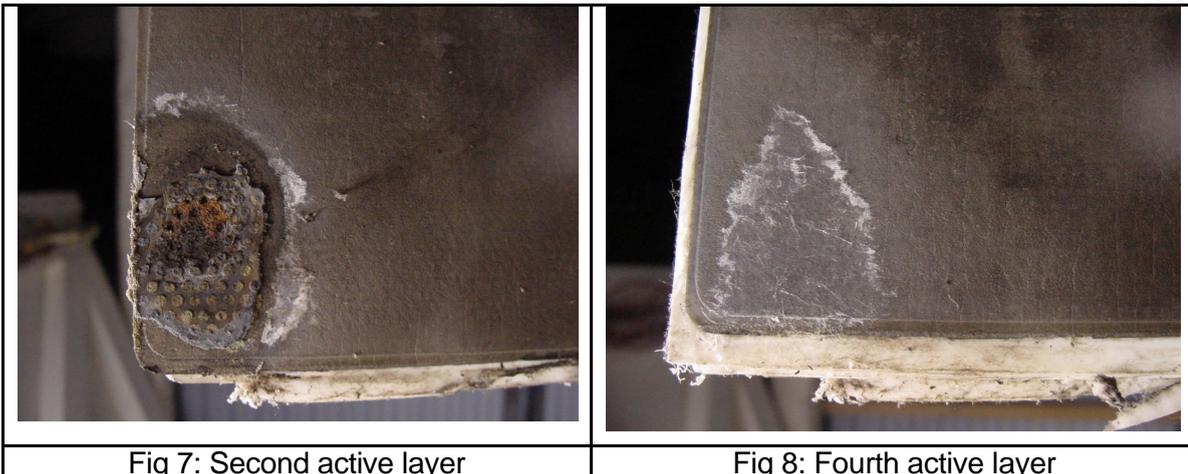
Below are pictures of the 2nd and the 4th active plate. As can be seen the heat influence reduces quite fast on the next layers so the short circuit has probably been between the 2nd and 3rd active plate.

Other battery blocks, which have been investigated shows similar defects and it can be expected that the type of defects are the same on all blocks with defects.
The most likely reason for the short circuit is a weak separator.
